EXPANDED FUNGAL REPORT TM

Report Date: 8/19/2022
Project: 219 W. Summerbell Ave., Elon, NC 27244
EMSL Order: 412208157

Spore Trap ASSESSMENT Report™ Air-O-Cell™ Analysis of Fungal Spores & Particulates (Methods MICRO-SOP-201, ASTM D7391)

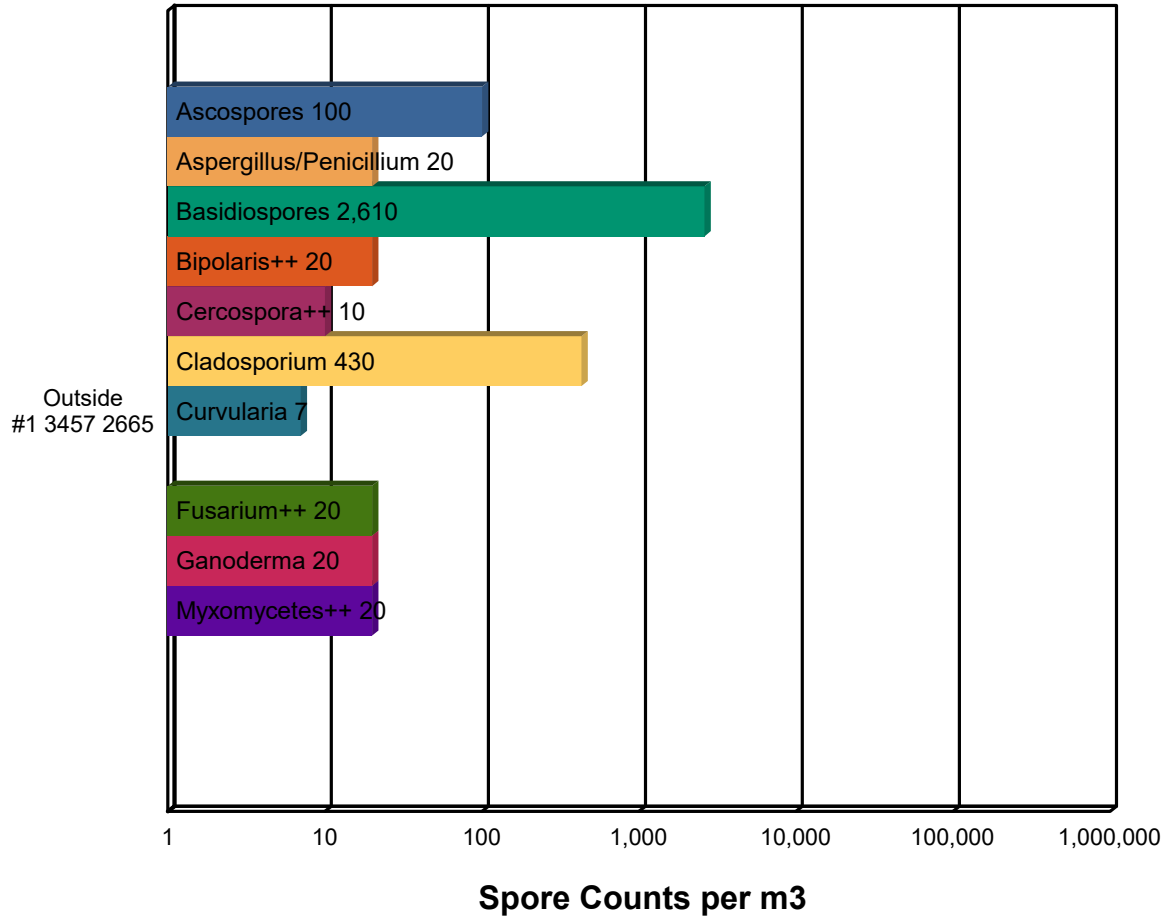
Spore Trap Report: Total Counts

Ascospores	Aspergillus/Penicillium	Basidiospores	Bipolaris++
Cercospora++	Cladosporium	Curvularia	Epicoccum
Fusarium++	Ganoderma	Myxomycetes++	Pestalotia++
Rust

* The chart is displayed using a logarithmic scale. Bar size is not directly proportional to the number of spores.

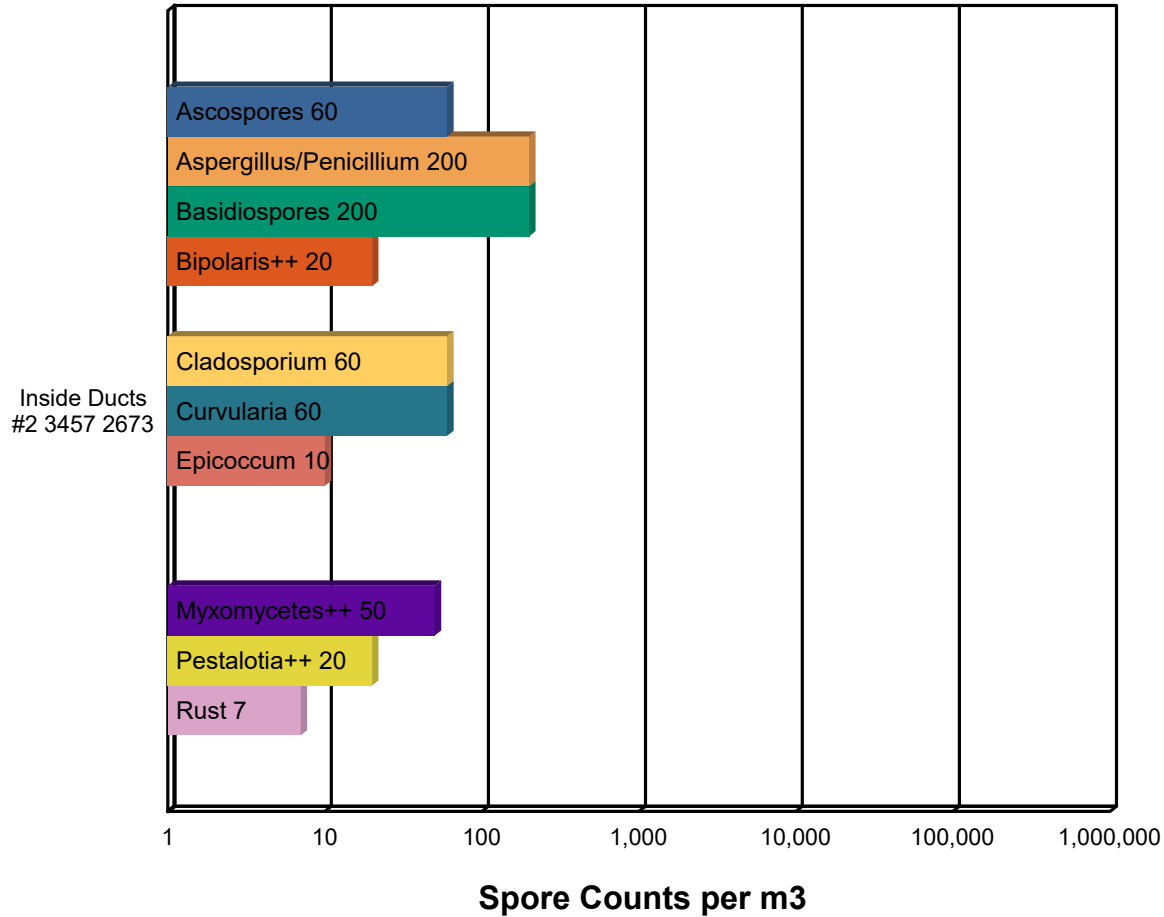
Spore Trap Report: Total Counts

Ascospores	Aspergillus/Penicillium	Basidiospores	Bipolaris++
Cercospora++	Cladosporium	Curvularia	Epicoccum
Fusarium++	Ganoderma	Myxomycetes++	Pestalotia++
Rust

* The chart is displayed using a logarithmic scale. Bar size is not directly proportional to the number of spores.

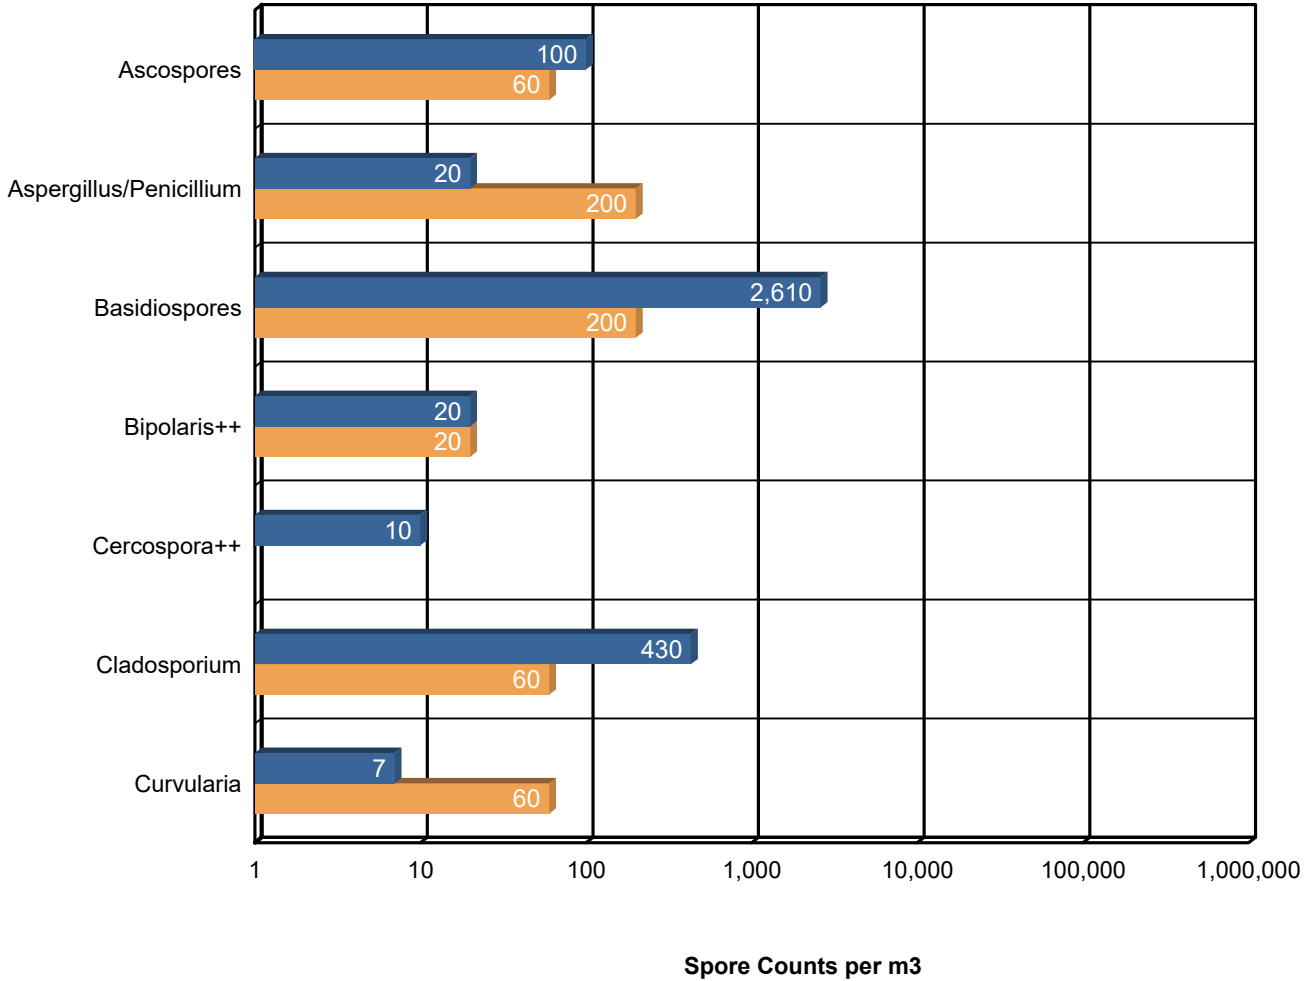
Background Comparison Chart

■ #1 3457 2665 Outside
 ■ #2 3457 2673 Inside Ducts

* The chart is displayed using a logarithmic scale. The bar size is not directly proportional to the number of spores.

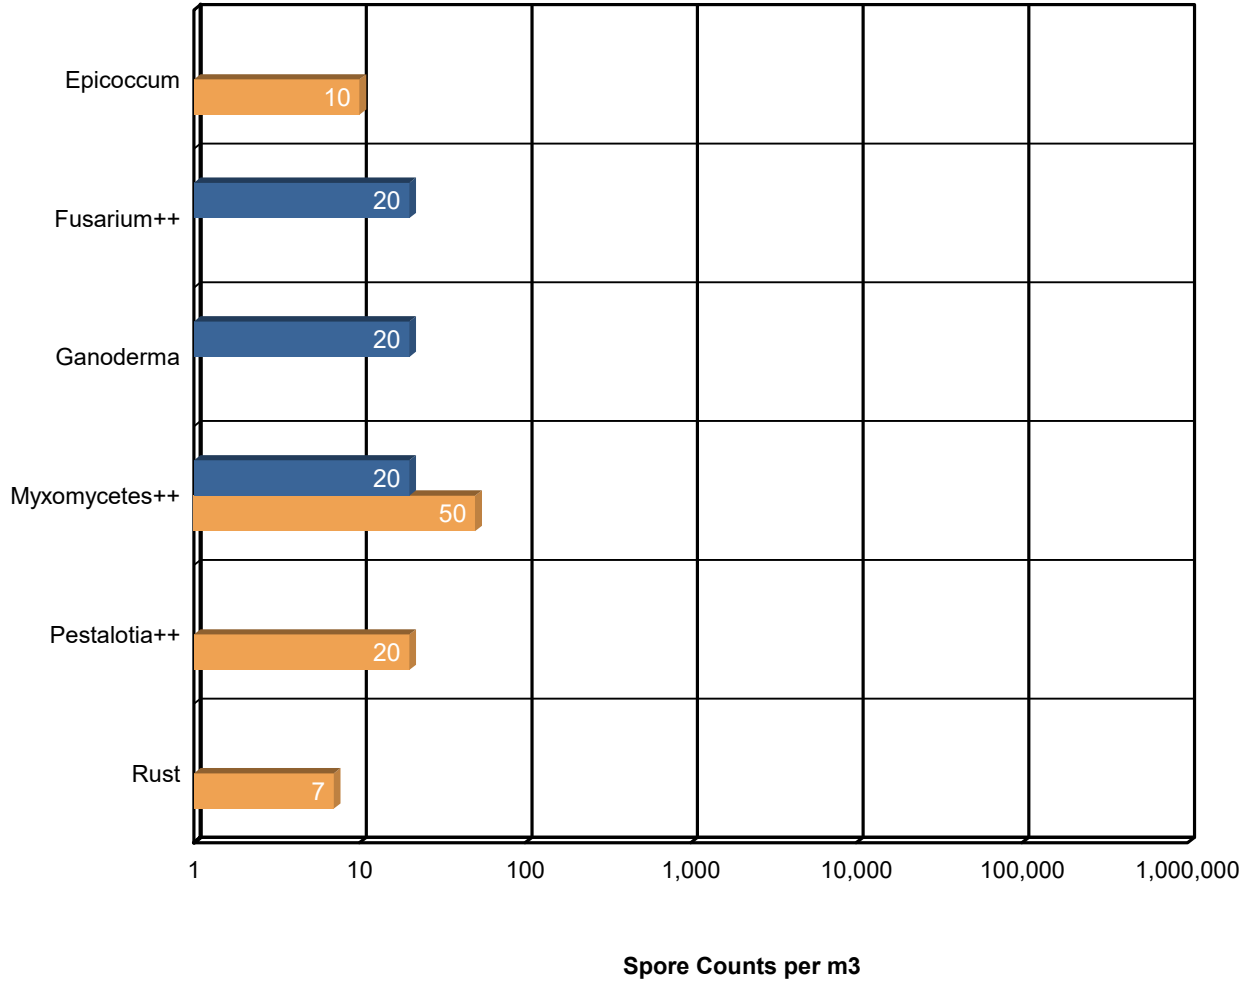
Background Comparison Chart

■ #1 3457 2665 Outside
 ■ #2 3457 2673 Inside Ducts

* The chart is displayed using a logarithmic scale. The bar size is not directly proportional to the number of spores.
